CASE STUDY—HONEYWELL

The Problem

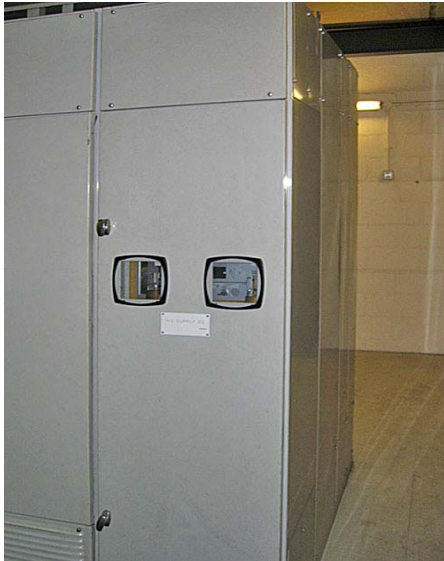
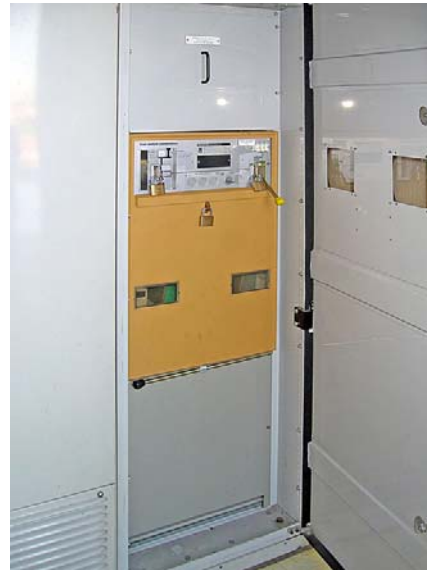
Honeywell are responsible for the operation and maintenance of buildings for blue-chip companies. During routine maintenance of the HV and LV systems of one of their clients in Birmingham City Centre, [ExEllison Switchgear Services](#) discovered a problem with the 11000V isolator close-coupled to the Package Substation transformer. Whilst the problem was temporarily overcome to ensure that power was returned to the building a solution for the long-term integrity of the supply was required.

The unit in question was of an obsolete design so spares were no longer available. Following consultation with [ExEllison Switchgear Services Ltd](#) a solution was devised to meet their specific circumstances.

It was agreed that a readily available unit of standard design be utilised to replace the faulty unit. With our knowledge of the Ellison equipment we were able to design the interface to enable simple replacement during a single 10 hour shutdown. All of the materials were custom built in advance of the agreed shutdown.

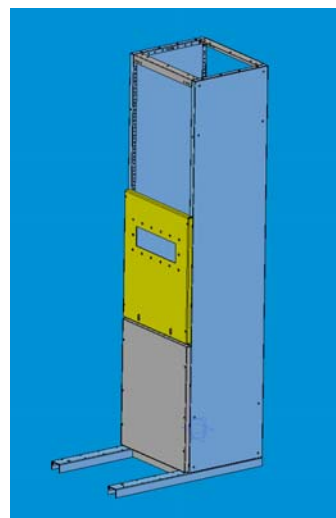
[ExEllison Switchgear Services Ltd](#) utilises the latest 3D solid modelling CAD systems to design its products to ensure a first-time fit every time. We have developed standard arrangements for a wide variety of retrofits. In this case a Schneider MV isolator was utilised in conjunction with our custom designed interface. The interface was designed to allow installation into the existing panel with the minimum of modification and down-time. A full assembly kit was supplied with no need for *cutting and carving* of parts to suit on site. Only the experience [ExEllison](#) have can guarantee a first-time fit without the need for a shutdown in advance of the installation.

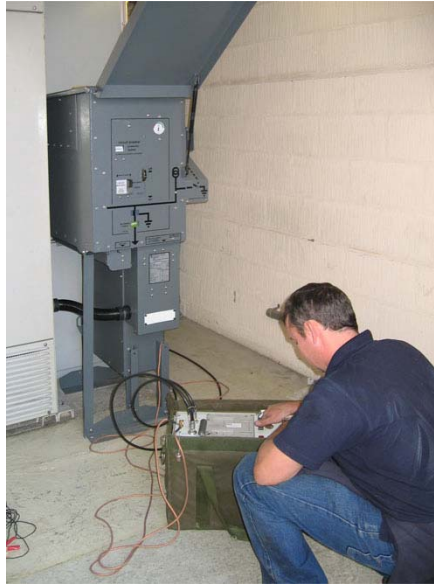
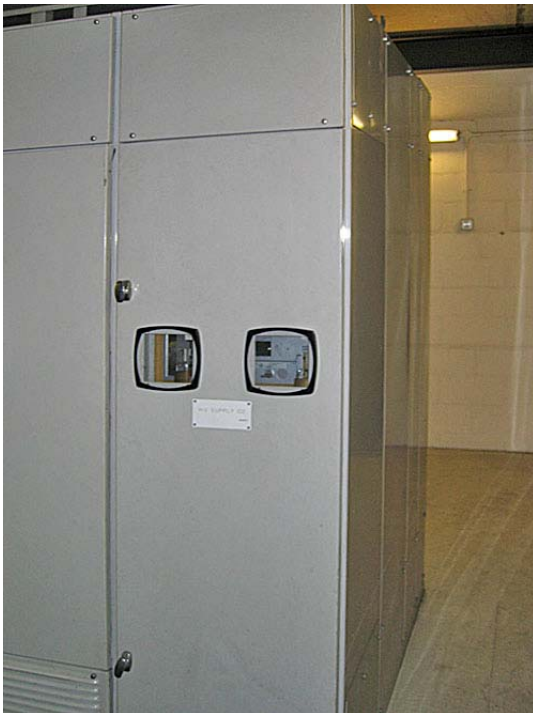
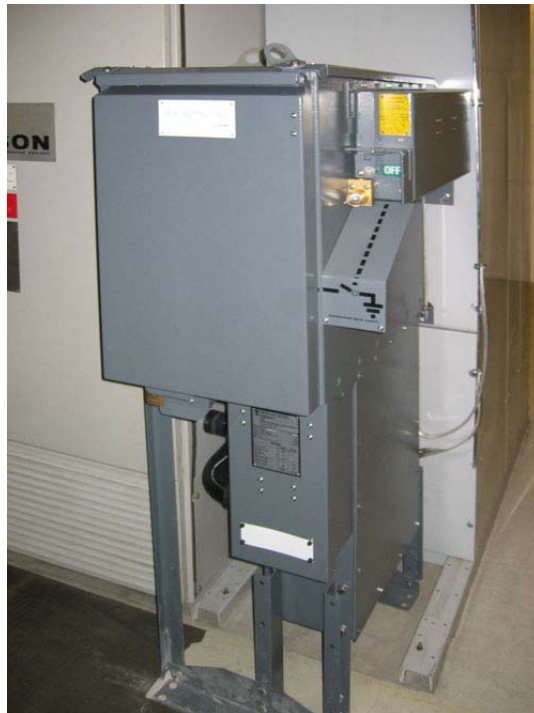
Further complications were introduced by the fact that the substation was located on the 7th floor of the building with the lift only reaching the 6th floor. Specialist lifting equipment was employed to ensure safe movement of the 300Kg isolator. Specialist HV Engineers ensured the correct termination of the 11kV cabling followed by thorough testing of the modified system before re-energisation.
