CASE STUDY—ACB REPLACEMENT

Mauri Products in Kingston-Upon-Hull are leaders in the production of yeast products. The 24-hour a day 7-days a week operation relies on a continuous electrical supply. Any interruption of supply would be disastrous to their business with major cleaning out of production equipment as well as loss of revenue to consider.

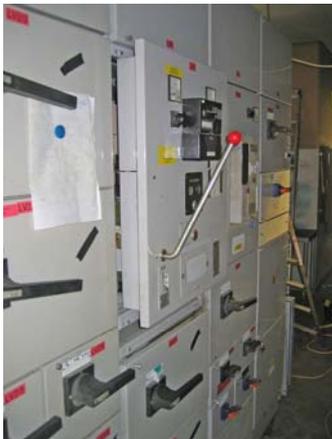
The main LV switchboard was some 15 years old and utilised Ellison GEA air circuit breakers. Whilst the ACBs had given years of good service they had encountered a number of problems with difficulty in closing and failure of the CPR relay fitted. There were also considerations made as to the problems in the supply of spare components in the event of future problems.

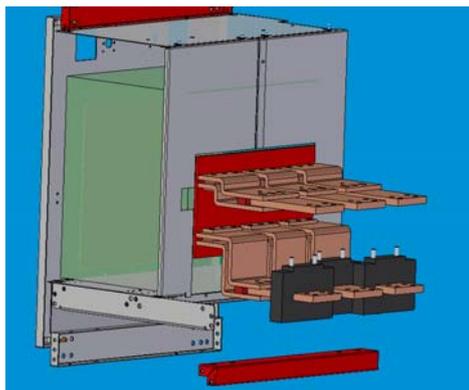
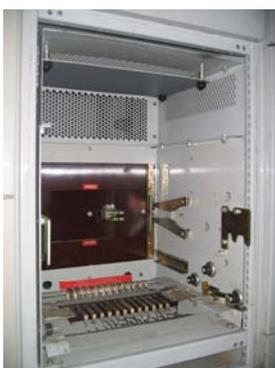
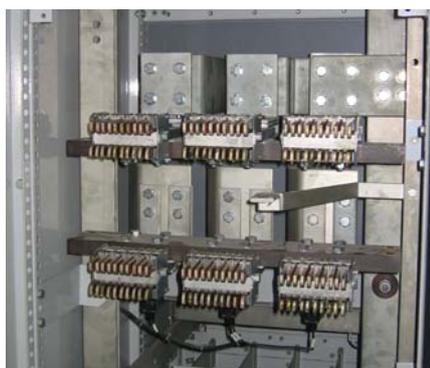
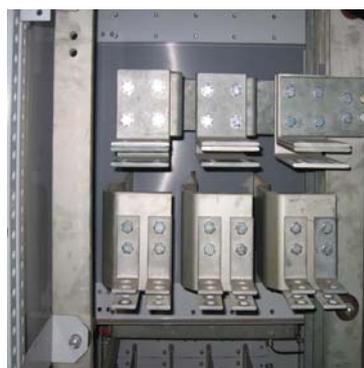
[ExEllison Switchgear Services Ltd](#) utilises the latest 3D solid modelling CAD systems to design its products to ensure a first-time fit every time. We have developed standard arrangements for a wide variety of ACB replacements. In this case ABB SACE ACBs were utilised. The interface was designed to allow installation into the existing panel with the minimum of modification and down-time. A full assembly kit was supplied with no need for *cutting and carving* of parts to suit on site. Only the experience [ExEllison](#) have can guarantee a first-time fit without the need for a shutdown in advance of the installation.

Note that [ExEllison Switchgear Services Ltd](#) does not install an ACB into an existing ACB chassis. There is little point in replacing an ACB whilst still relying on aged contact finger clusters. We take the old ACB out completely right back to the basic connections. This weak point is removed to ensure the integrity of the new assembly.

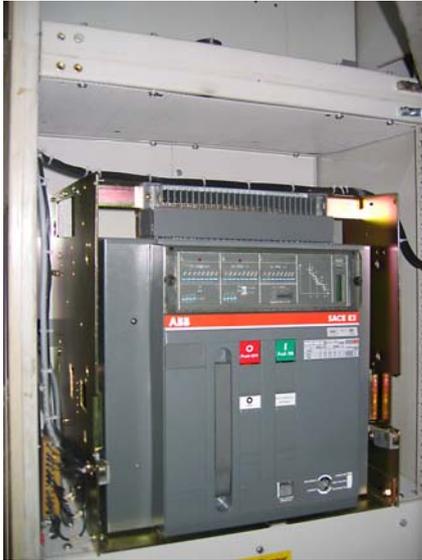
Typically the removal of an old ACB and the installation of a new replacement ACB is completed within an 8-hour shutdown. In this case the two main incoming ACBs were replaced in a 12-hour shutdown. ExEllison's knowledge of the standard wiring loom enabled the existing metering to be easily utilised with the new ACB. The CTs were relocated in the new ACB copperwork.

Internal shrouding is fitted to make the ACB module complete. A fully shuttered Cassette is used to ensure the operators safety.

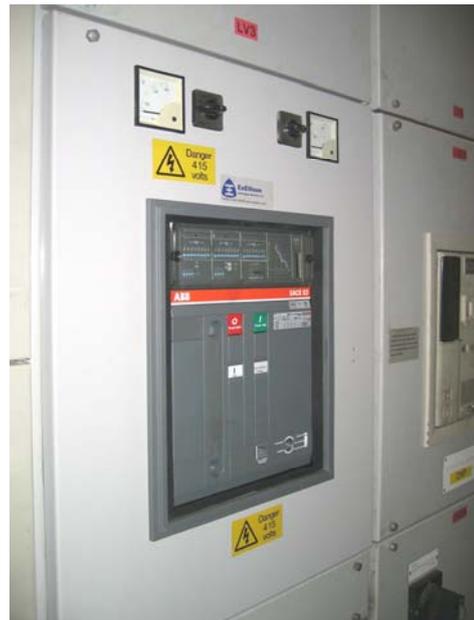
The installation is completed and the equipment returned to service following ACB testing. The equipment is now suitable for continued use at a fraction of the cost of a replacement switchboard and all of the associated civil and cabling works.
